COMBINED FIRE AND HEALTH & SAFETY RISK ASSESSMENT.

Address of premises:	Croft, Newport, Southwich & Scott House Brock End; Swindon; SN1 3HB
Responsible Person:	Brock End RTM Company Ltd
Duty Holder:	Block Management Limited
Person(s) consulted:	No occupier or other relevant person available to consult.
Assessor:	Rob Cockburn
Report validated by:	John Godfrey, GIfireE.
Date of fire risk assessment:	23 rd October 2024/ Reviewed Oct 2025
Date of previous fire risk assessment:	N/K
Suggested date for review:	October 2026

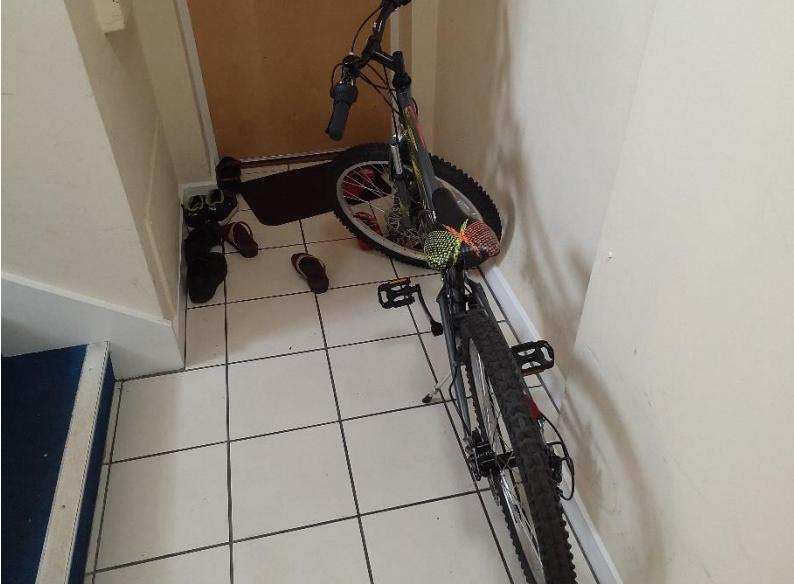
03	<p>Housekeeping was found to be of a poor standard at the time of this assessment for Croft house, Newport house and both entrance to Southwich House with the communal areas and escape routes congested with residents' possessions and storage. It is recommended that the client arrange for the communal areas to be cleared as a priority and all residents reminded of the importance of maintaining sterile communal areas and escape routes.</p>

2	<p>B</p> <p>Ongoing action required</p> <p>DH inspect communal areas and ticket items for removal.</p> <p>Residents are reminded of sterile area policy via notice board and website.</p>

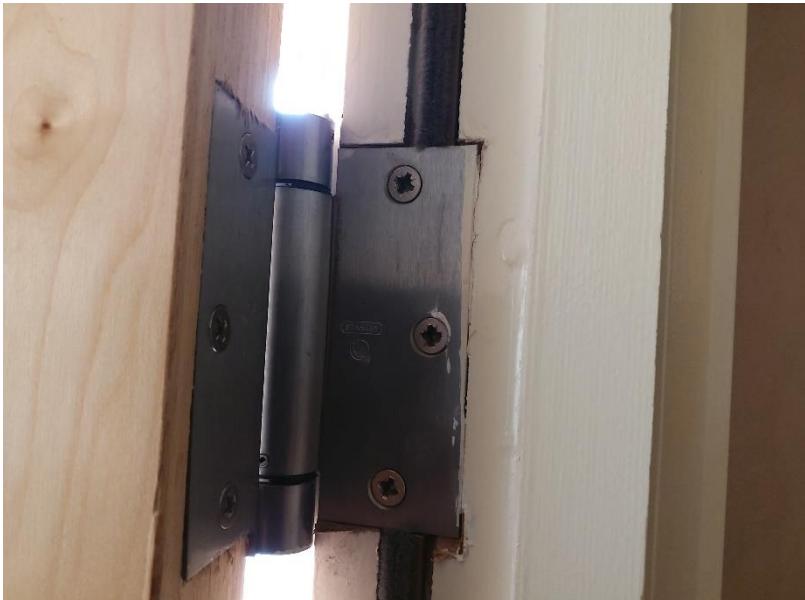
04	<p>All contractors employed by the client must supply risk assessments and method statements prior to working. It is recommended that the client give all contractors induction training prior to commencing work, which should include emergency procedures.</p> <p>Additionally, the client should arrange to conduct a post work inspection of the work area to ensure all works have been completed satisfactorily and safely, with no residual hazards present that could compromise the fire safety of the premises.</p>	3	C	Ongoing action required DH action as required
05	<p>It was noted during this fire risk assessment that the following doors had non-fire rated hinges: Croft house electrical intake cupboard, Newport house electrical intake cupboard and Scotts house electrical intake cupboard. This could cause the doors to fall from its leaf in the event of a high temperature fire. It is therefore recommended that the RP instructs a suitably qualified and competent contractor to rehang each door on three grade 13 hinges in order to maintain the integrity of the doorset and protect the means of escape.</p>

2	C	Action complete

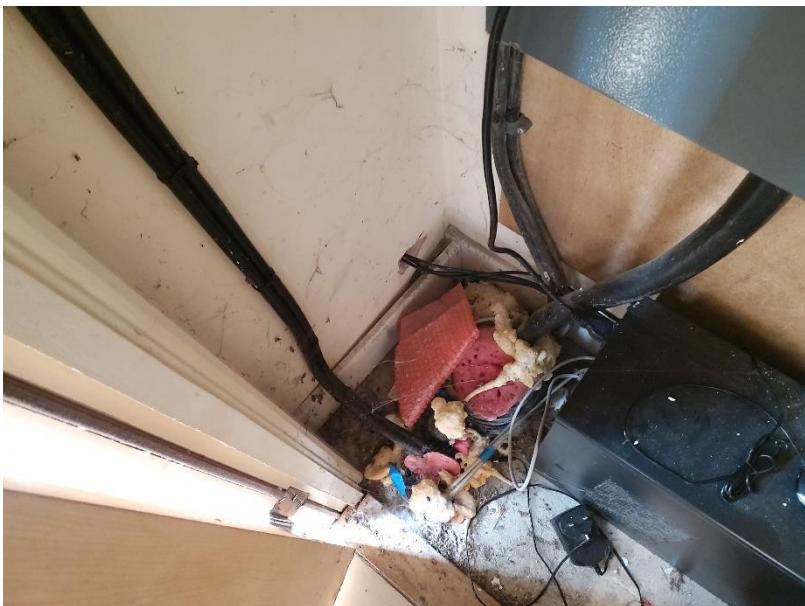
08	<p>It was noted during this fire risk assessment that there was an overuse of intumescent sealant or foam within the following areas; electrical intake cupboard of Newport house, electrical riser in the left entrance of Southwich House, electrical intake cupboard in the right entrance of Southwich House, electrical intake cupboard in Scotts House. Intumescent sealant and foam are used to seal other fire-resistant materials and should not be used as the main fire resisting compound due to the inconsistent viscosity causing the integrity to fail at different time frames within a fire. It is therefore recommended that the RP instructs a suitably qualified and competent contractor to replace this overuse of sealant or foam with a compound capable of providing a consistent minimum of 30 minutes fire resistance (like pink plasterboard) in order to protect the means of escape from smoke and fire.</p>

2	<p>B</p>

<p>Action required</p> <p>Contractor has made appropriate repairs.</p> <p>Further advice to be obtained as required.</p>

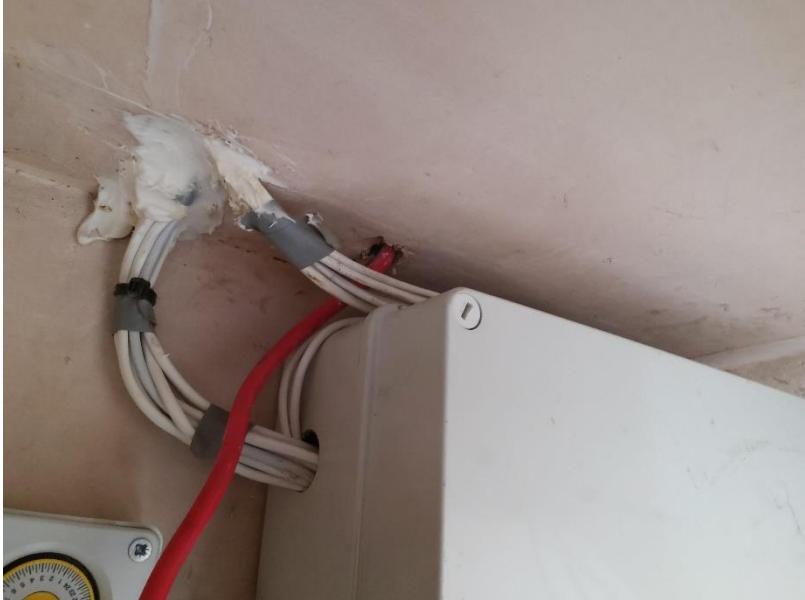
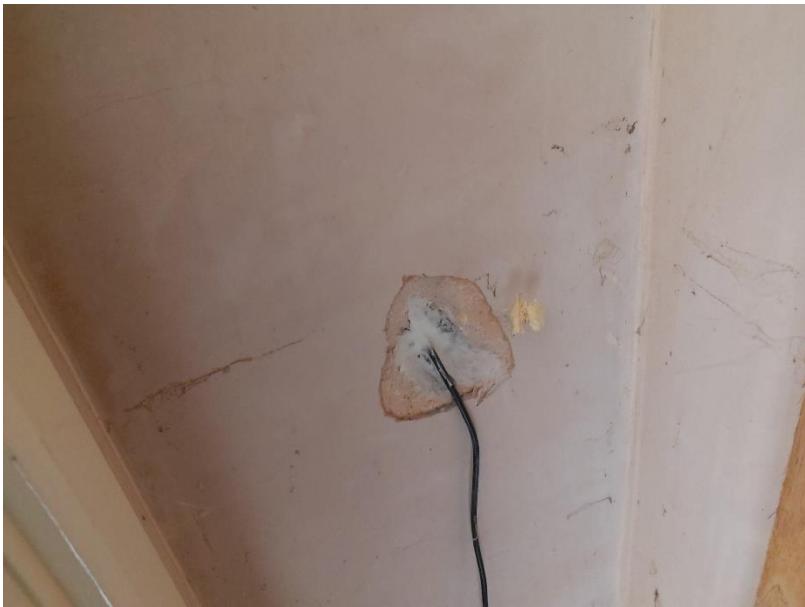
09	<p>It was noted during this fire risk assessment that there were breaches in the following areas: within the electrical intake cupboard of Scotts House and electrical intake cupboard of the right entrance of Southwich House. Additionally, there is a breach that has not been repaired appropriately within the electrical intake cupboard of the right entrance of Southwich House. This could allow smoke and fire to spread into the means of escape or undetected throughout the premises which could contradict the stay put policy and/or impede persons escape from the building. It is therefore recommended that the RP instructs a suitably qualified and competent contractor to repair the breaches with a suitable compound capable of providing a minimum of 30 minutes fire resistance in order to protect the means of escape.</p>

<div style="display: flex; justify-content: space-between; align-items: center;"> 2 B </div>

Action required As above

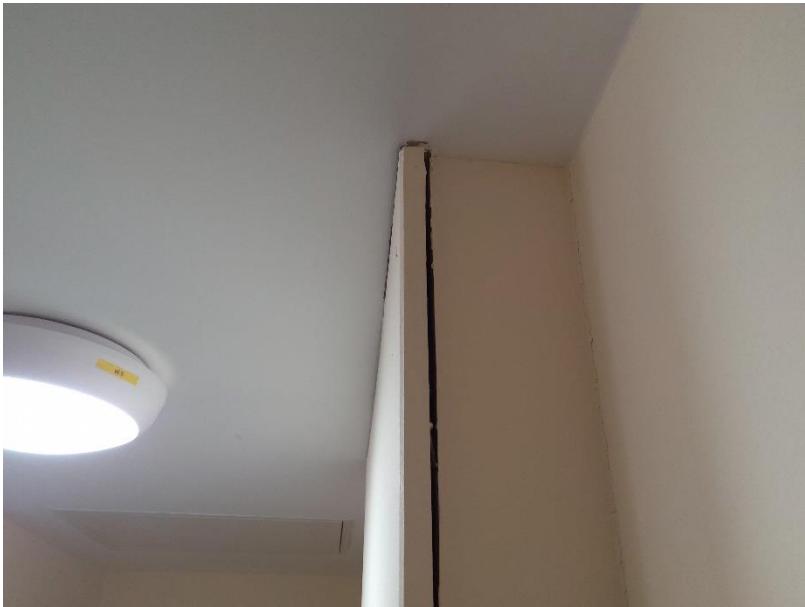
10	<p>It was noted during this fire risk assessment that the panelling on the second floor of the right entrance of Southwich House appeared to be damaged and coming away from the wall. This could allow smoke and fire to spread into the means of escape which could stop/impede persons escape from the premises and also allow smoke and fire to spread undetected through the building. It is therefore recommended that the RP instructs a suitably qualified and competent contractor to repair this panelling in order to protect the means of escape.</p>

2	B	<p>Ongoing action required Contractor has made adjustments.</p> <p>No items stored behind panel.</p>
11	<p>Emergency lighting is installed within the common areas of the left entrance of Southwich House however the nodes do not appear to be charging. This could delay a safe and prompt evacuation in low ambient light conditions. It is recommended that the client consult with a competent contractor to repair the emergency lighting as a priority.</p>

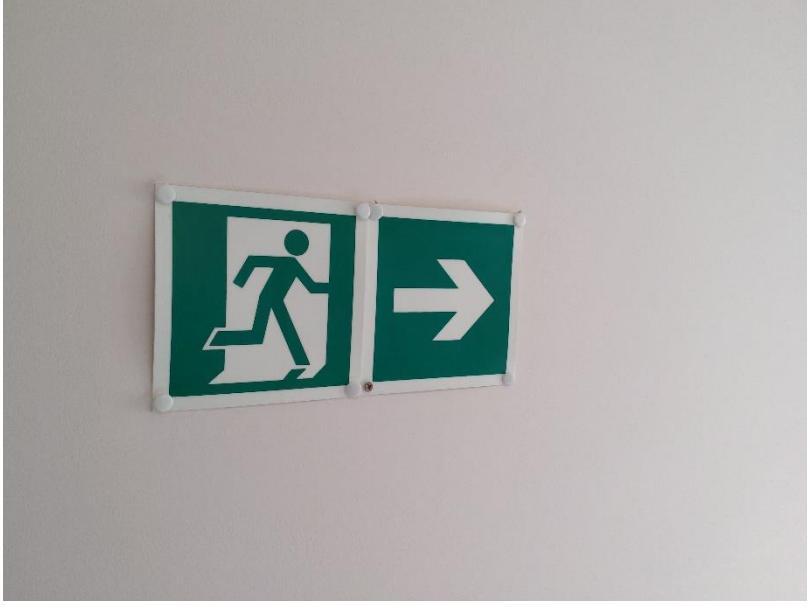
12	<p>Directional signage is installed within all blocks however it does not conform to safety signs and signals: the health and safety regulations 1996. Due to the simple layout of each block it is recommended that all signage is removed.</p>

3	B	Action required Contractor to remove prior to redecoration
13	<p>It was noted during this fire risk assessment that there is a decommissioned alarm panel within each block. Consideration could be given by the RP as to its removal. This is in line with current fire safety guidance for purpose-built flats.</p>
